***Bison 2 Wind
Project
Interim
Construction
Inspection Report***

Allete, Inc.

PU-11-57

July 2012

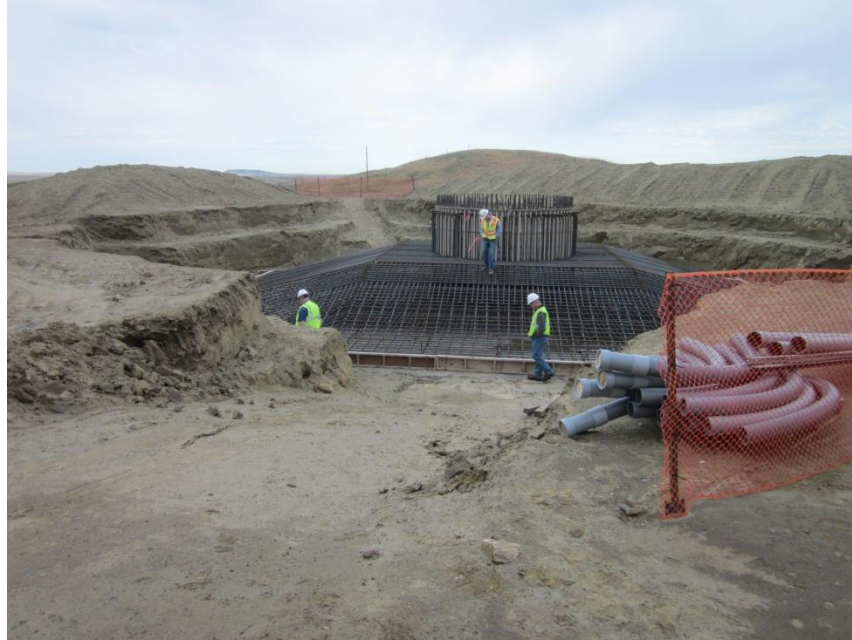
Photo 1. Direction: Southwest. The base of Structure 215.

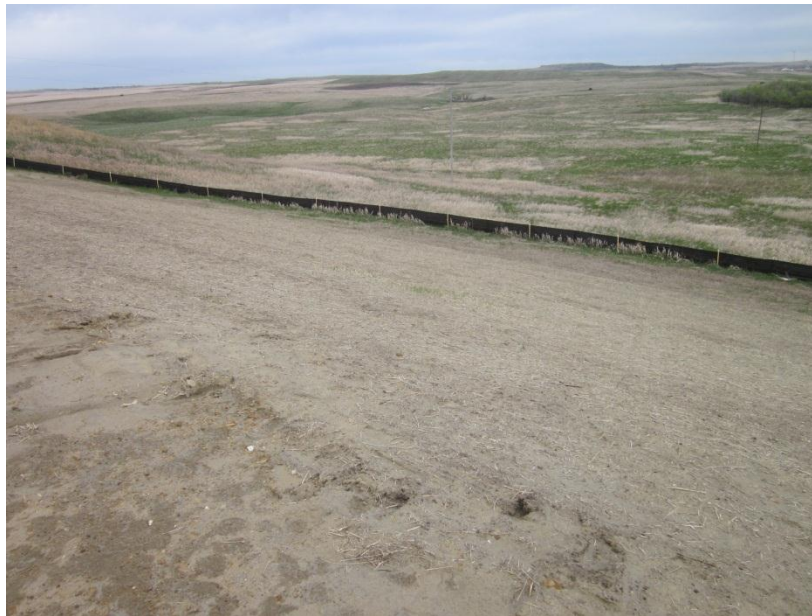
Structure bases appeared to have been constructed in accordance with the Application and all necessary PSC requirements. Silt fences had been installed surrounding each structure base, preventing erosion to the surrounding area (**Appendix B, Photos 2, 4, 5**). Topsoil had been segregated and mounded with necessary erosion controls in place (**Appendix B, Photos 4**).

Photo 2. Direction: Northwest. Slope that had been reseeded with erosion control fencing nearby Structure 215. Erosion control surrounded the entire structure footprint.

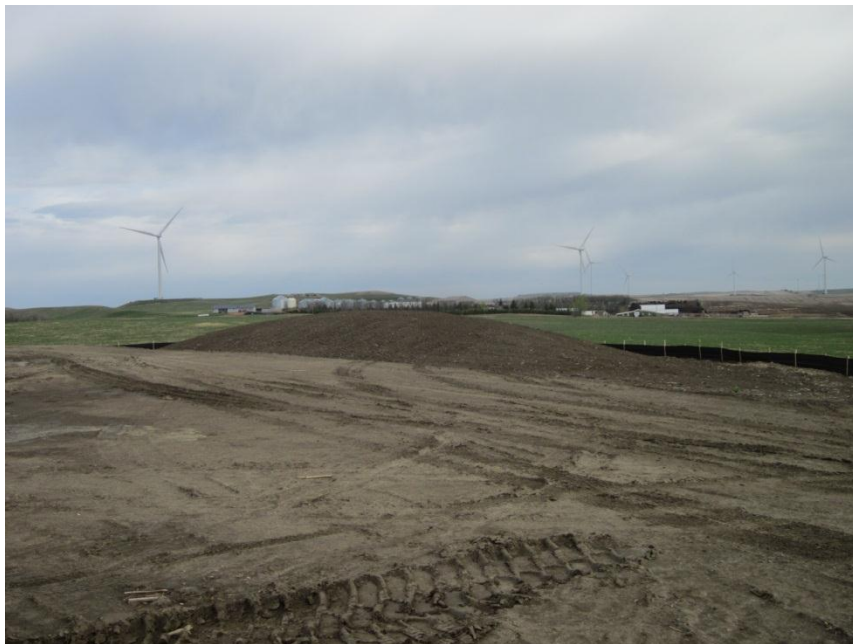
Photo 4. Direction: South. Example segregated topsoil pile at Structure 212. All topsoil was mounded on site, with appropriate erosion controls at all structure locations.

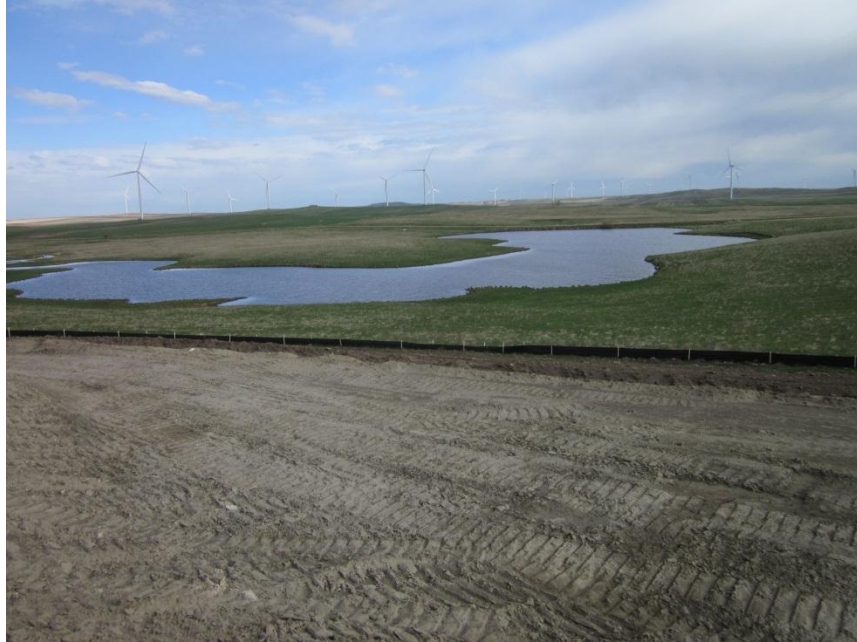
Photo 5. Direction: Northwest. Example silt fence at preventing erosion to nearby wetland at Structure 208.

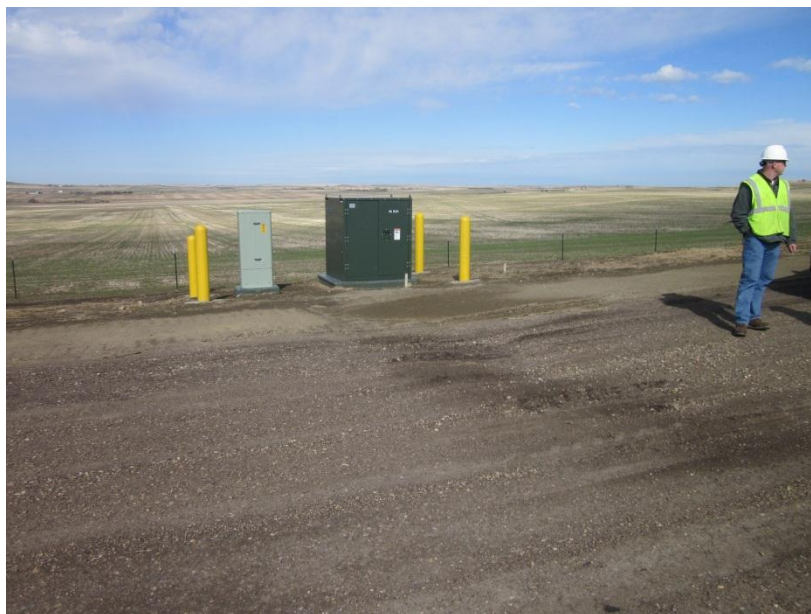
transportation safety (**Appendix B, Photo 3**). All access roads that had been constructed had appropriate culverts in place to facilitate natural surface water flow. In addition, all access roads had appropriate signage (e.g. stop signs at intersections on section lines). There was one low area that needed to be repaired at the time of the inspection (**Appendix B, Photo 6**). However, this area was fixed after Project inspection.

Photo 6. Direction: West. Transformer with appropriate safety bollards in place. The access road in this photo had a slight low area, which was reportedly repaired after the inspection.

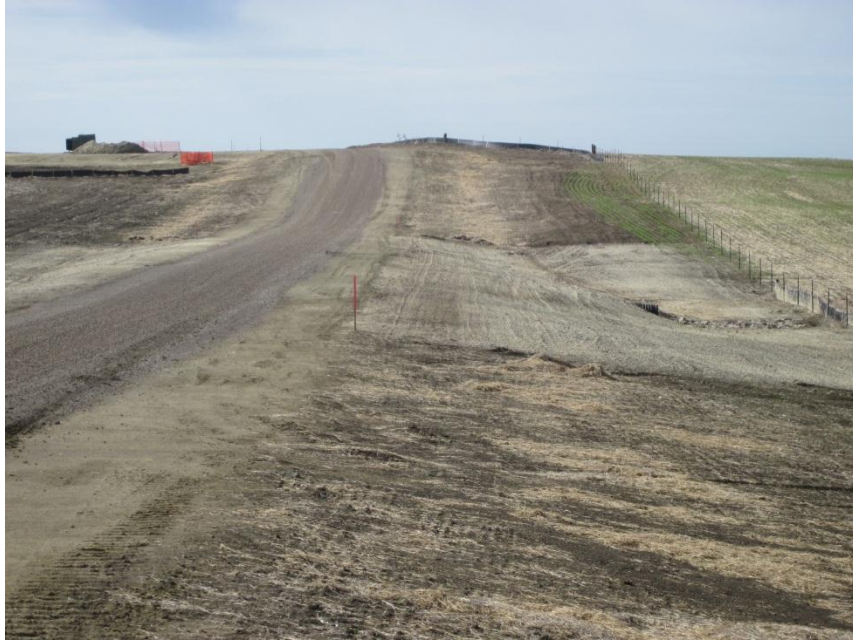
Photo 7. Direction: South. Access road to Structures 224 and 225. Note mesh netting and rocks at base of culvert for erosion control.

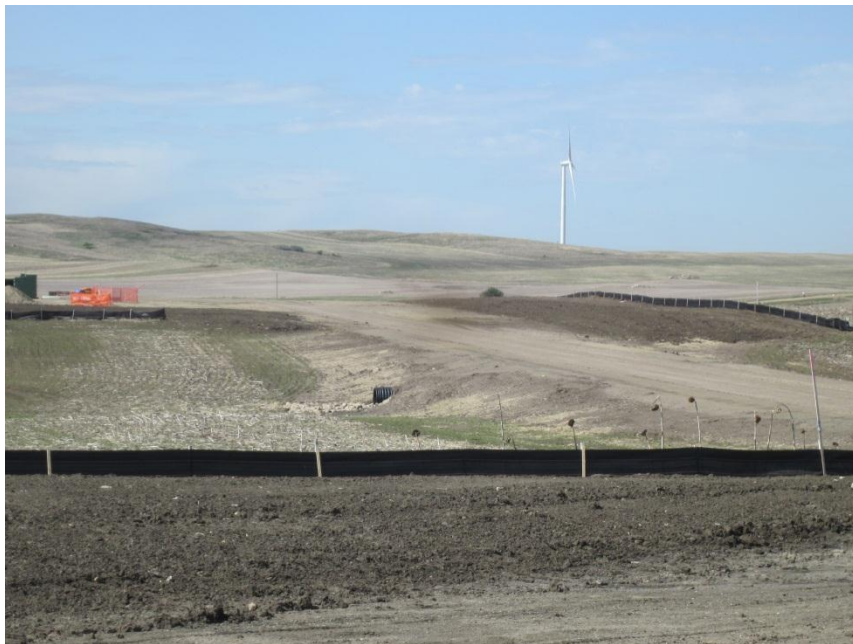
Photo 8. Direction: Southwest. Access road for Structure 202. Note silt fence and rocks at base of culvert for erosion control.

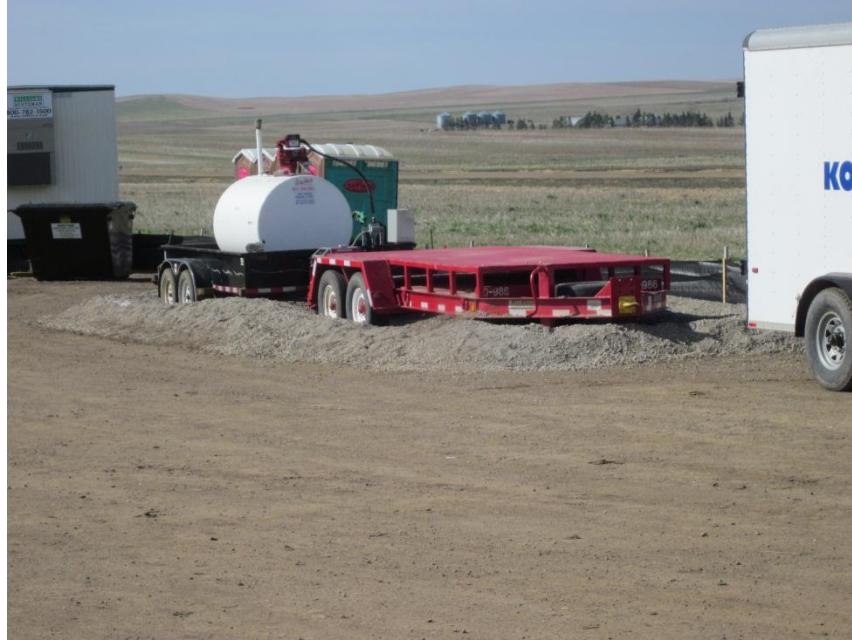
The laydown area used for the project was observed, and it appeared to be very well maintained, organized, and in good condition (**Appendix B, Photos 9, 10**). Particularly of note was a diesel tank that had been surrounded by gravel to prevent any possible contamination by accidental spills. This attention to detail was apparent in all aspects of the current Project's implementation.

Photo 9. Direction: Southwest. This diesel tank, located in the laydown yard, had been surrounded by gravel to prevent spills

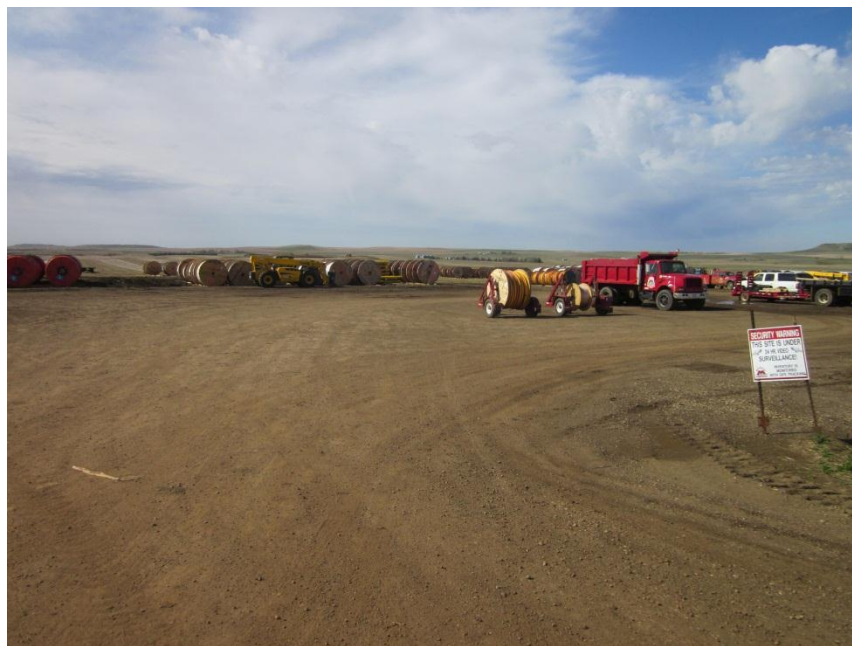
Photo 10. Direction: South. Project laydown yard, which was organized and well maintained.
